SIXTH EDITION

# 2020 PV Module Reliability Scorecard

PV EVOLUTION LABS

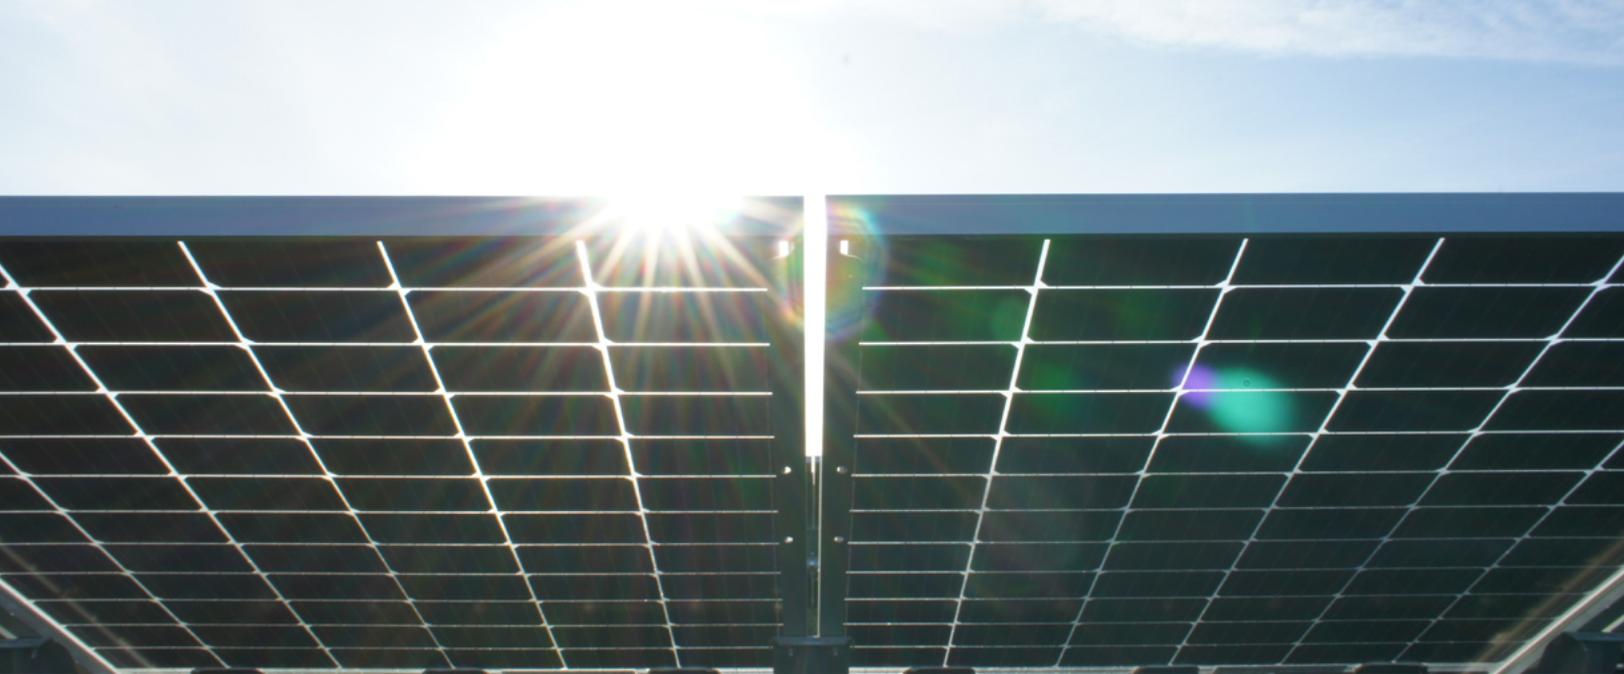
PV module defects are outlined in the chart to the right. PVEL has identified a selection of field-replicated defects following shipping or stress testing in the table below.

Failure Mode	Test Sequence	Likely Cause	Project Impact
<b>Glass breakage</b>

Damp heat (Pg. 18)	Poor component selection and/or improper potting technique	Safety issues
<b>PID</b>

PID (Pg. 22)	Poor component selection, cell design and/or quality control	Increased power loss
<b>Diode failure</b>

Thermal cycling (Pg. 16)	Poor diode selection and/or manufacturing quality control	Increased power loss; safety issues
<b>Busbar corrosion</b>

Damp heat (Pg. 18) and humidity freeze (Pg. 20)	Poor lamination quality and/or component selection	Increased power loss
<b>Delamination</b>

Damp heat (Pg. 18) and humidity freeze (Pg. 20)	Poor lamination quality and/or component selection	Increased power loss; safety issues

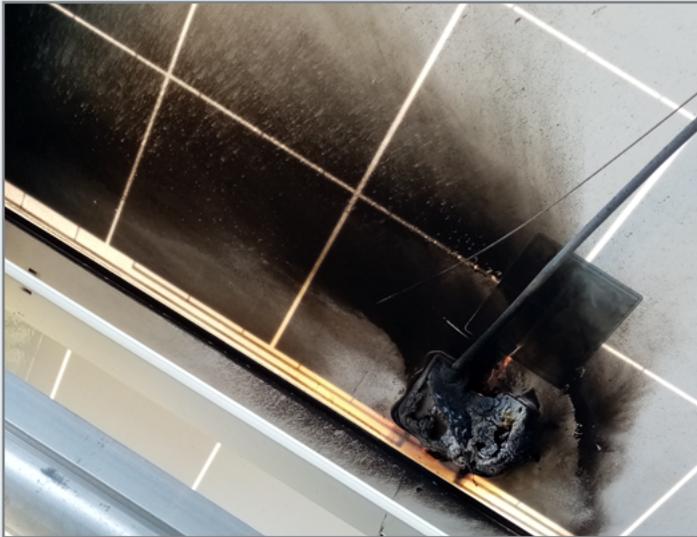
The image above shows a PV module at the project site with a junction box that melted due to electrical arcing.

A 50 MW PV plant in Africa built in 2013 began to exhibit serious failures from poor soldering and failed diodes after just five years of operation.

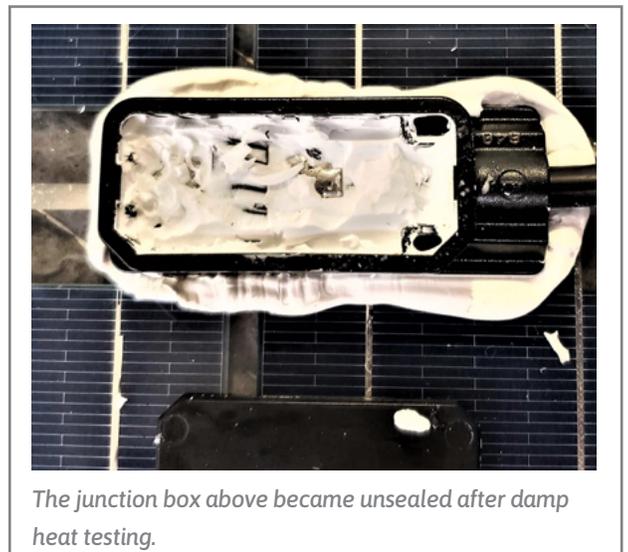
The junction box above became unsealed after damp heat testing.

Many of the recorded wet leakage failures were traced to poor sealing around the junction box via the junction box lid, adhesive or pottant. Correct placement of the lid and application of sealants are critical manufacturing processes, but they can be overlooked in the pursuit of production targets.

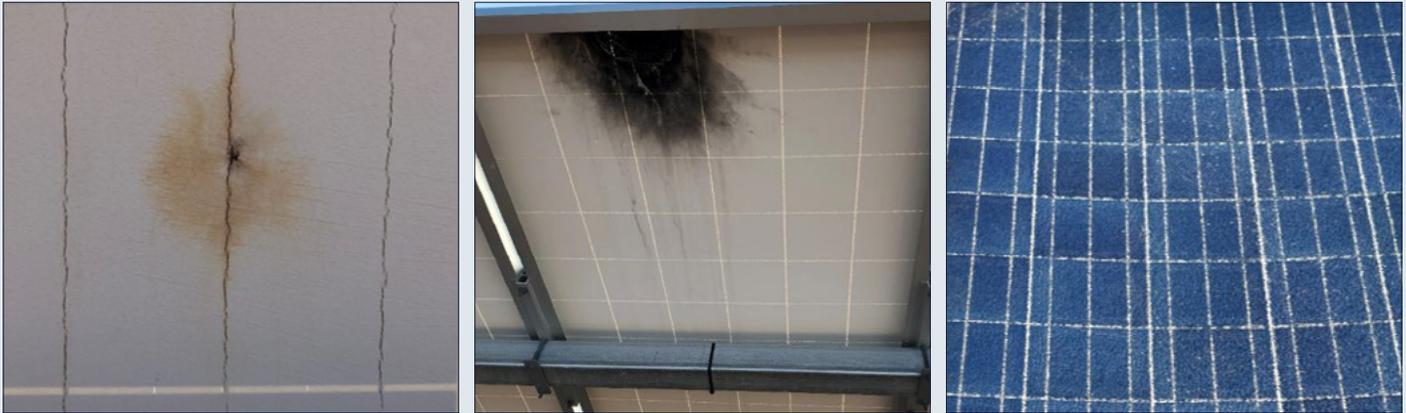
The pictures above are from a 17 MW project in the Southwest U.S. One hundred percent of the backsheets in this project are cracked. The severe scorching in the backsheet above was caused by electrical arcing at the backsheet cracks that intercept the frame. The thermal event shattered the front-side glass.

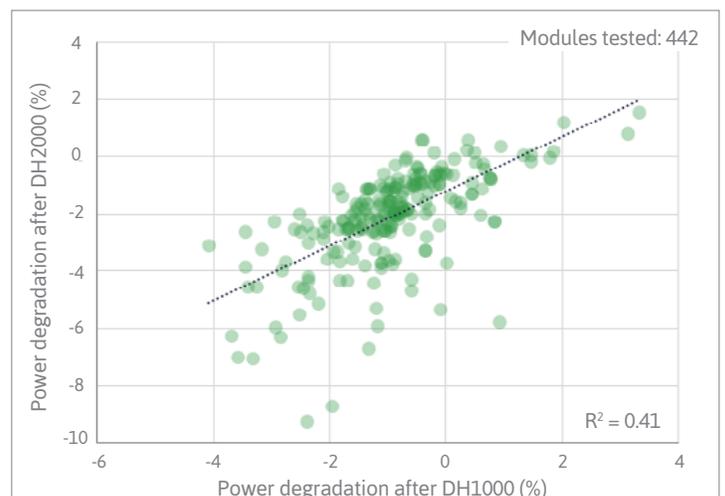
Scatterplots showing correlations between various stages of the TC and DH tests

For the thermal cycling test, the correlation between 200 cycles and 600 cycles indicates no new mechanisms are being introduced by the 600 cycle test, yet stopping at 200 cycles might be premature (see figure below left). Reviewing the historical 600 cycle and 800 cycle correlation indicates that TC600 is a sufficient test duration. The damp heat correlation between 1000 hours and 2000 hours suggests 1000 hours is not an adequate substitute for 2000 hours (see figure below right), while the historical correlation between 2000 and 3000 hours indicates that less relevant failure mechanisms may be introduced. The data shows that 2000 hours is optimal.
